# SITE REPORT No. 10

<b>TO</b>	<b>Matthew Josephson, Ron Krachenfels</b> Perma Construction
<b>FROM</b>	<b>Peter Johannknecht</b>
<b>CC</b>	<b>Bruce Lemire-Elmore, SROL Parish</b> <b>Darryl Condon, HCMA</b> <b>Consultants</b>
<b>PROJECT</b>	<b>SROL Church</b>
<b>DATE</b>	<b>2012.01.12</b>

Date of visit: 2012.01.11, 3:00pm  
 Weather: Sunny, 4C  
 Present: Bruce Lemire-Elmore, Peter Johannknecht, Ron Krachenfels, Paul Little, Al Strickland, Dave Neufeld

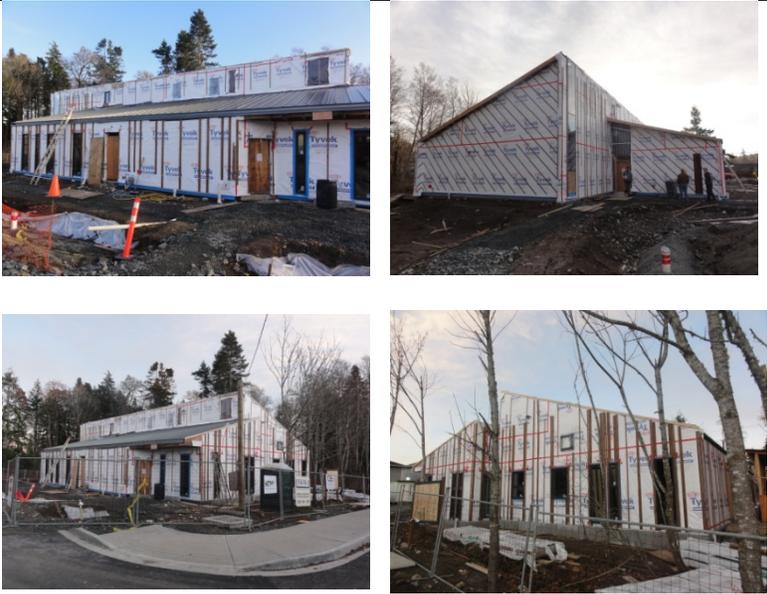
Exterior framing at 100%. Metal roofing at 98%. Air barrier installation at 95%. See separate item below.	
10.2

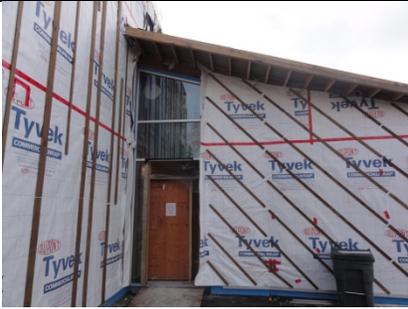
The vapour barrier is sealed to the wood structure, but additional caulking is required at the wood block transitions at the header and sill prior to the installation of the drywall.	<b>INFO</b>
10.5

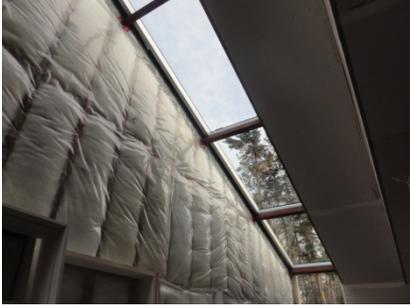
<p>The aluminum curtain walls are installed with the sealed glazing units, except the 2 triple glazed vents.</p>	
10.6

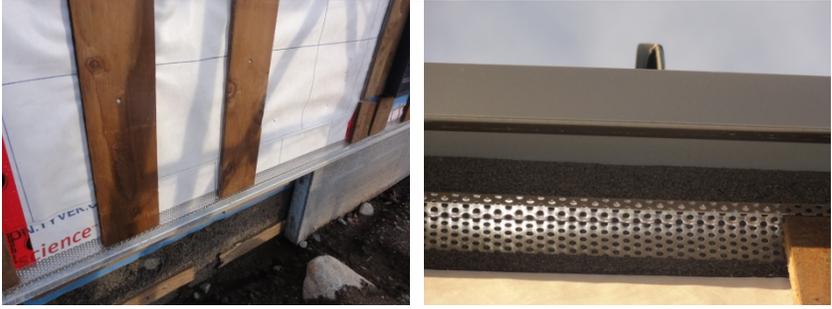
<p>Drip flashing and insect screens are in place with the furring strips for the rain screen cladding systems.</p>	<p><b>INFO</b> <b>PERMA</b></p>

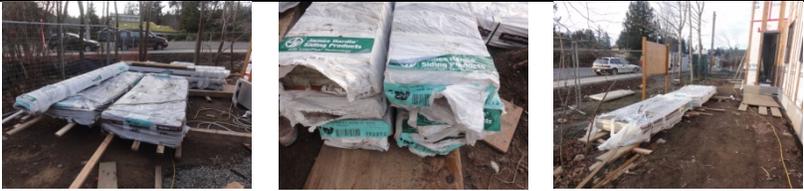
<p>The cement panels are stored on site. It was pointed out that some require additional support for a level storage until they are ready for installation</p>	<p><b>INFO</b> <b>PERMA</b></p>

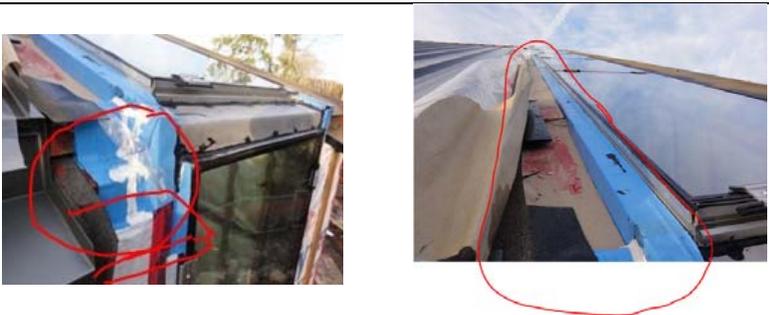
<p>The metal roof assembly has to be extended to the curtain wall mullion. The VB has to be tied back to the mullion as well. According to the detail provided in the doc. The gutter flashing has to extend to the curtain wall beyond the steel bump-out and covered with a counter flashing to drain the water.</p>	<b>INFO</b> <b>PERMA</b>

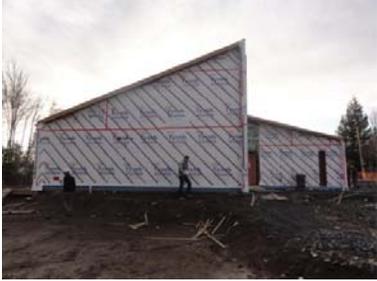
<p>Diagonal furring for the vertical cedar siding is in place.</p>	<p>INFO</p>
<p>10.14</p>

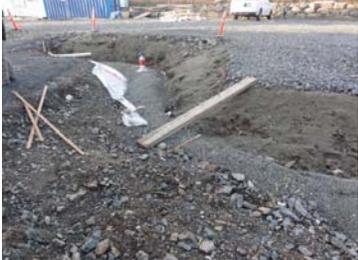
<p>Rain garden drain pipe is covered. Review by Landscape Architect or Civil Engineer is requested prior to further concealing the work.</p>	<p>INFO</p>
<p>10.15</p>

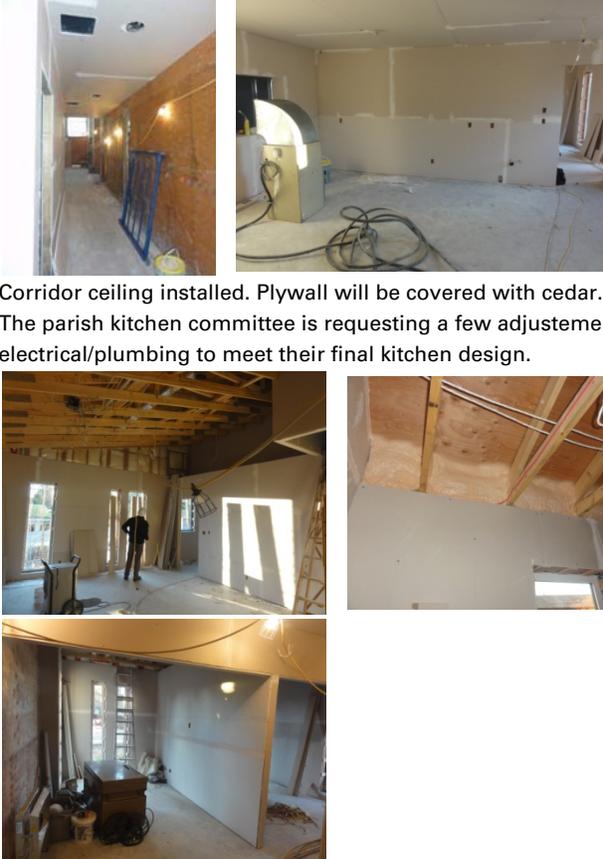
<p>Corridor ceiling installed. Plywall will be covered with cedar. Kitchen drywalled. The parish kitchen committee is requesting a few adjustments of the electrical/plumbing to meet their final kitchen design.</p>

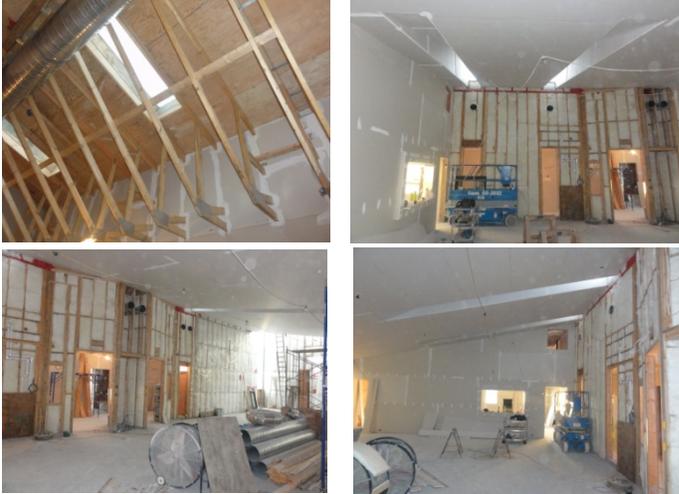
<p>Ceiling in nave/hall boarded up and ready for taping/mudd.</p>	INFO
10.17

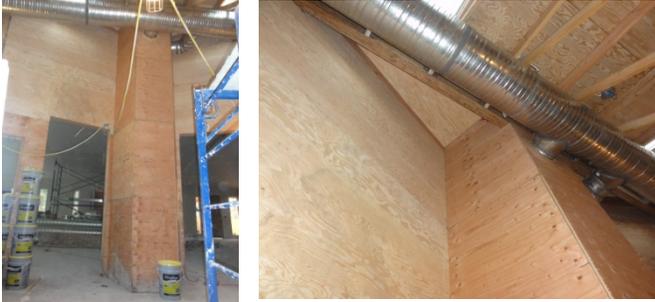
<p>V-column at the main entrances to the nave is completed and ready for the cedar and door installation.</p>	INFO
<b>End of Site Report Number 10</b>
